FACADE DEGRADATION ASSESSMENT IN HERITAGE BUILDINGS: A UAV-BASED APPROACH FOR THE CHURCH OF OUR LADY OF MOUNT CARMEL IN OLINDA-PE.

Apresentado no
Congresso Técnico Científico da Engenharia e da Agronomia – CONTECC
06 a 09 de Outubro de 2025

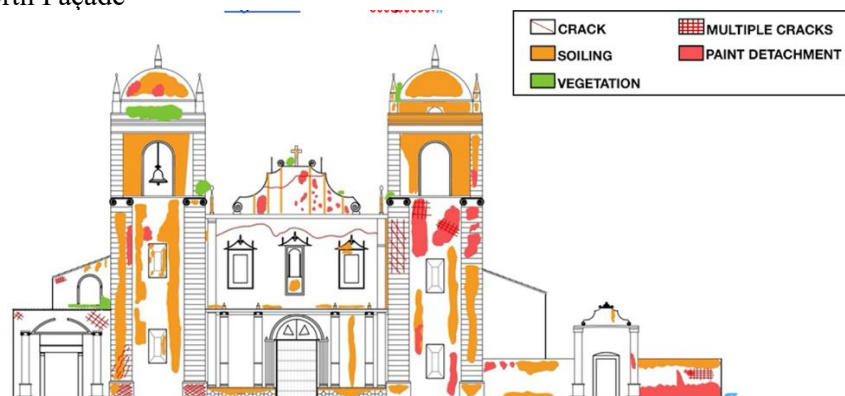
Figure 01 - North Façade

Inspection of the façades revealed varied distribution and severity of pathological manifestations across the four orientations of the building. The North Façade recorded the highest absolute number of pathologies (133 occurrences), predominantly soiling (71 occurrences) and paint detachment (34 occurrences), likely due to its exposure to wind, moisture, and pollution. Figure 01 illustrates the North Façade.

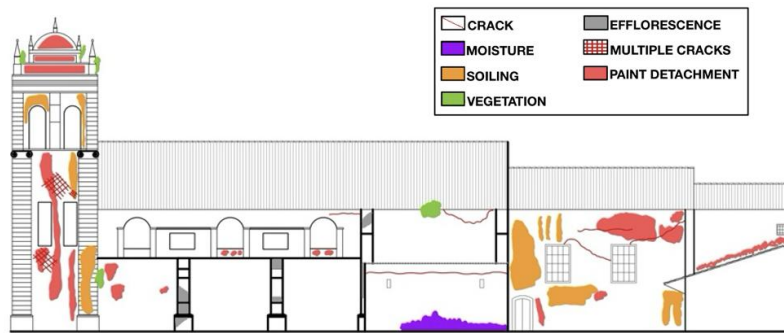
Figure 02 - West Façade

In contrast, the West Façade presented a lower total number of pathologies with 51 occurrences. Paint detachment (20 occurrences) and soiling (10 occurrences) were predominant, as shown in Figure 04. This lower incidence may relate to reduced exposure to climatic factors or protection from adjacent urban elements.

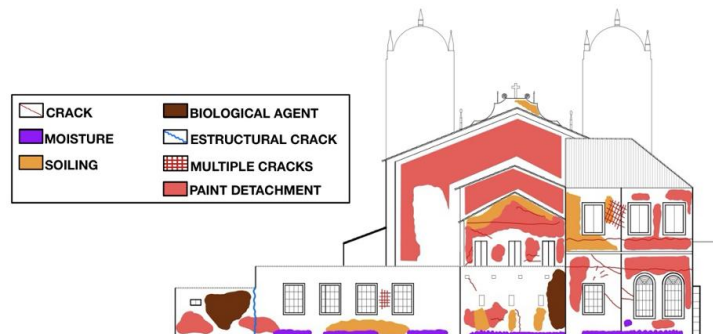
Figure 03 - South Façade

The South Façade recorded 56 occurrences, also a lower volume compared to the North Façade. As depicted in Figure 05, cracks (19 occurrences) and paint detachment (18 occurrences) were the most notable.

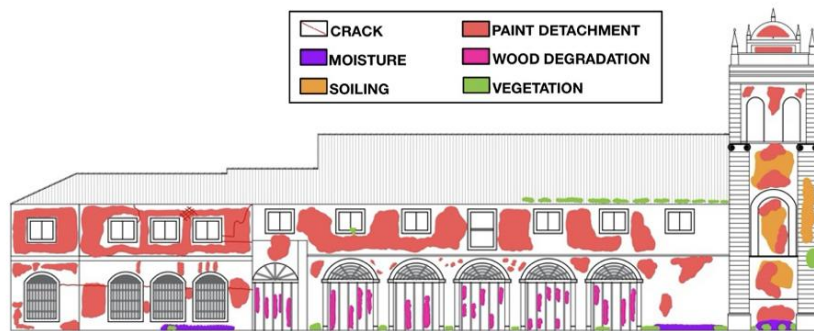
Figure 04 - East Façade

The East Façade showed a high number of anomalies with 121 occurrences, making it the second most affected. As seen in Figure 06, paint detachment (53 occurrences), vegetation (25 occurrences), and wood degradation (28 occurrences) were prominent, possibly indicating strong sun exposure, wetting/drying cycles, or rainwater drainage failures.
