FACADE DEGRADATION ASSESSMENT IN HERITAGE BUILDINGS: A UAV-BASED APPROACH FOR THE CHURCH OF OUR LADY OF MOUNT CARMEL IN OLINDA-PE.

Apresentado no
Congresso Técnico Científico da Engenharia e da Agronomia – CONTECC
06 a 09 de Outubro de 2025

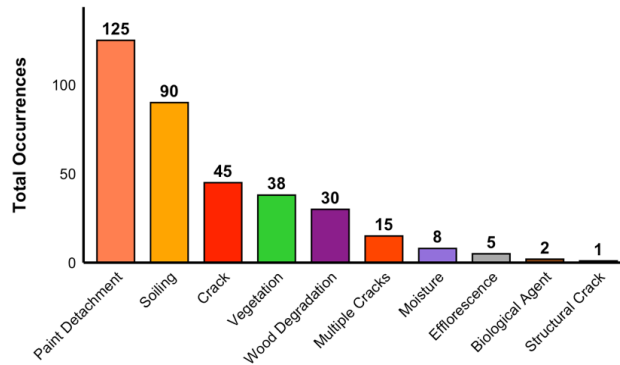
Figure 05 – Total Incidence of Pathological Manifestations on the Façades

This differentiated distribution of pathologies by façade highlights the importance of detailed inspection for each side, as environmental conditions and usage significantly affect material deterioration.

The presence of wood degradation, moisture, efflorescence, and biological agents indicates critical issues related to water management. Structural cracks, though less frequent, demand priority attention due to their potential to compromise building stability. The Pearson correlation matrix, visualized as a heatmap in Figure 06, provided crucial insights into interrelationships.

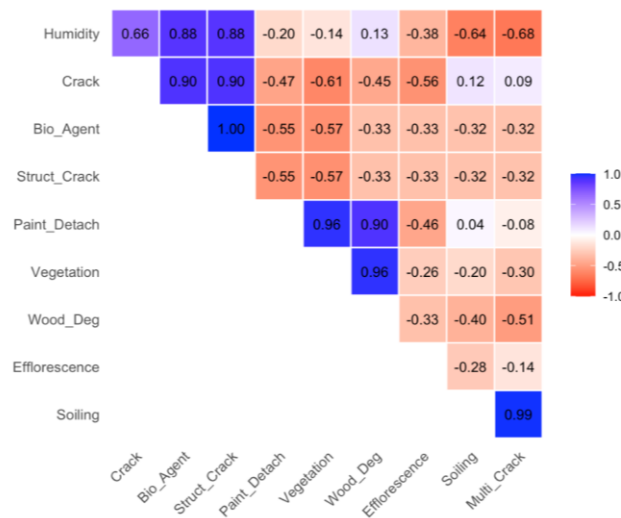
Figure 06 – Correlation Matrix of Pathological Manifestations

Correlation analysis (values from -1 to +1, with blue tones indicating positive and red negative correlations) revealed key patterns. Moisture showed very strong positive correlations with Cracks (0.88), Biological Agent (0.88), and Structural Cracks (0.88), confirming its role as a triggering factor for fissures and biological growth (Espinosa et al., 2008; Blocken et al., 2013). Interestingly, it exhibited a negative correlation with Soiling (-0.68), suggesting distinct degradation mechanisms. Paint Detachment correlated strongly with Vegetation (0.96) and Wood Degradation (0.90), indicating a progressive cycle where vegetation contributes to wood degradation, affecting paint adhesion (Guerra et al., 2019; Barrellas et al., 2023). Soiling showed a strong correlation with Multiple Cracks (0.99), suggesting that fissured surfaces tend to accumulate more dirt (Flores-Colen et al., 2008; Souza et al., 2016). A perfect correlation (1.00) between Biological Agent and Structural Cracks suggests that cracks create microenvironments for biological growth. These patterns guide integrated

interventions and reinforce the need for detailed inspections for early detection and intervention (Guerra et al., 2019; Mathur et al., 2024).
